# Manhole Inspection Summary

Manhole # S45EE\_004MH

Insp Date: **6/19/08 8:28 AM**

**Location** Address: **Wolfe**

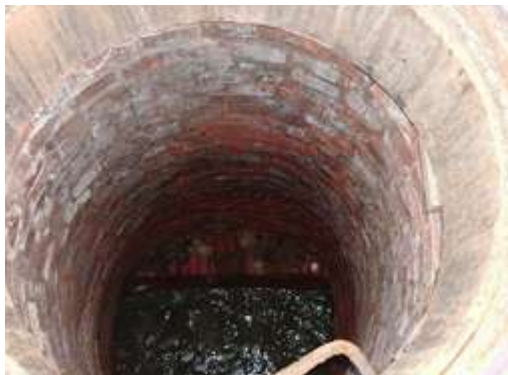
Defect 2

Infiltration

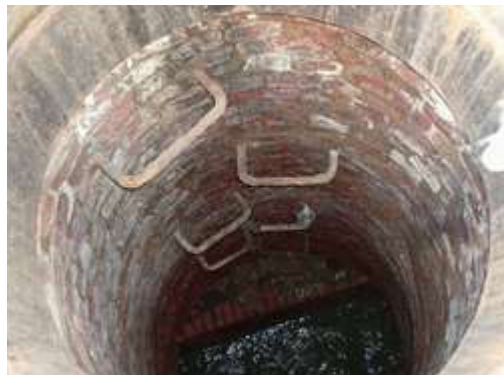
Defect 1

☒ **Leaks**

Frame Leaks

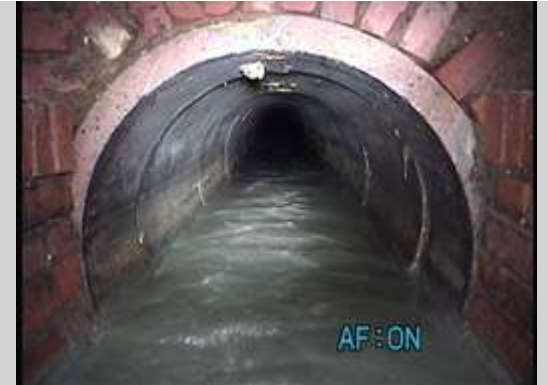
12 O'Clock Outflow

24 in. Circular Gravity Sewer  
Pipe Out @ 12 O'Clock

Pipe Height: **24** (in.) Rod and Bar (Angled)  
Pipe Material: **Clay** ☐ Pipe Lined  
Invert Depth: **11.65** (ft.) Flow Characteristics: **Fast**  
Deposits: ☒ None ☐ Mud ☐ Sludge ☐ Debris ☐ Grease  
Silt Depth: (in.) Deposits Extent:  
Infiltration: **None** Pipe Seal Cond: **Sound**

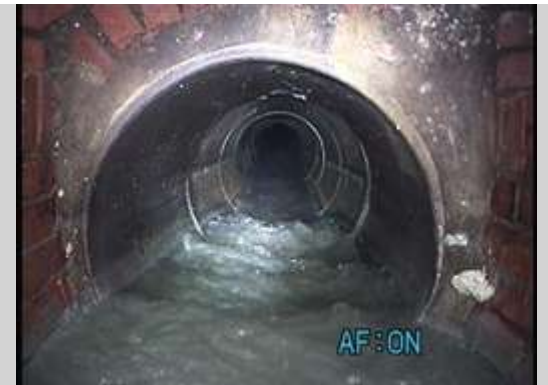
6 O'Clock Inflow

21 in. Circular Gravity Sewer  
Pipe In @ 6 O'Clock

Pipe Height: **21.6** (in.) Rod and Bar (Angled)  
Pipe Material: **Clay** ☐ Pipe Lined  
Invert Depth: **11.60** (ft.) Flow Characteristics: **Fast**  
Deposits: ☒ None ☐ Mud ☐ Sludge ☐ Debris ☐ Grease  
Silt Depth: (in.) Deposits Extent:  
Infiltration: **None** Pipe Seal Cond: **Sound**

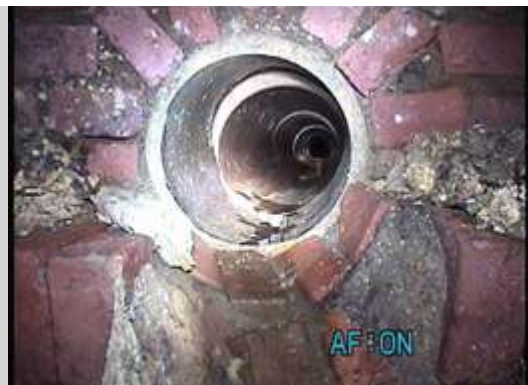
9 O'Clock Inflow

8 in. Circular Gravity Sewer  
Pipe In @ 9 O'Clock

Pipe Height: **8.4** (in.) Rod and Bar (Angled)

Invert Depth: **10.15** (ft.) Flow Characteristics: **None**
